Analysis of the Stream Restoration Design of Donaldson Run Tributary B in Arlington, VA

Dr. John Field

Field Geology Services

December 2020

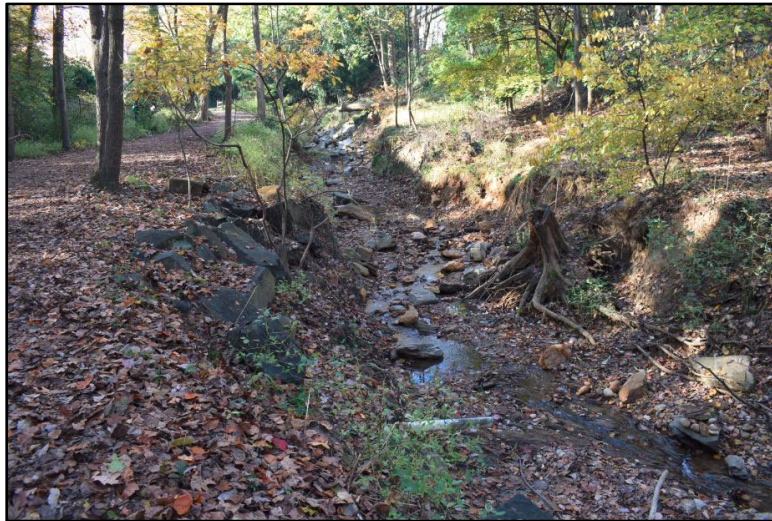
Figure 2. The upper portion of Tributary B has incised below the flat surface over which the stream once flowed.

The watershed draining to Donaldson Run Tributary B has impervious surfaces covering more than 26 percent of its area (VHB, 2019, Drawing number D-1). This has increased runoff to the stream compared to pre-development conditions while simultaneously reducing the amount of sediment available for transport. The resulting imbalance between the level of water and sediment entering Tributary B has engendered a channel response in the form of channel incision and bank erosion seen along the upper portion of the proposed restoration reach (Figure 2).

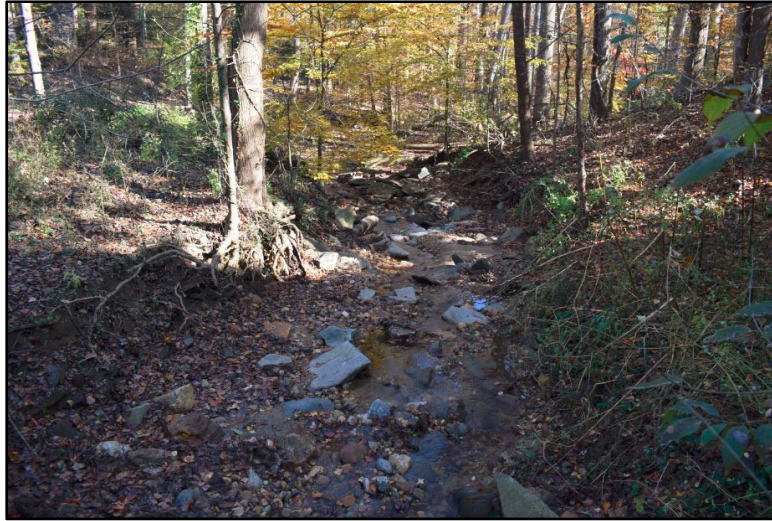
Figure 3. Tributary B is self-stabilizing near the footbridge with sediment accumulating on the channel bottom.

large rock from past bank stabilization efforts (Figure 3). Trees falling into the stream during this latter phase of bank widening have the potential to stabilize the bank and enhance aquatic habitat. Consequently, the area of the channel below the pedestrian bridge, while still eroding in places, is nearing a stable (but not static) condition in equilibrium with the urbanized watershed.

boulder structures often occurs in less than 20 years as is evidenced by the numerous isolated boulders found on the bed of Tributary B derived from past bank stabilization efforts (Figure 3).

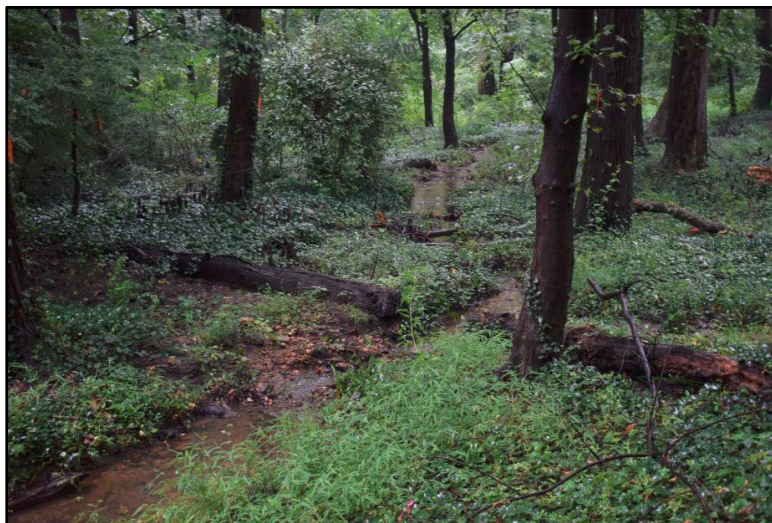
Figure 4. A small shallow channel flowing on an ancient valley bottom in the Hollin Hills neighborhood of Alexandria, VA is similar to how Tributary B likely looked prior to urbanization.

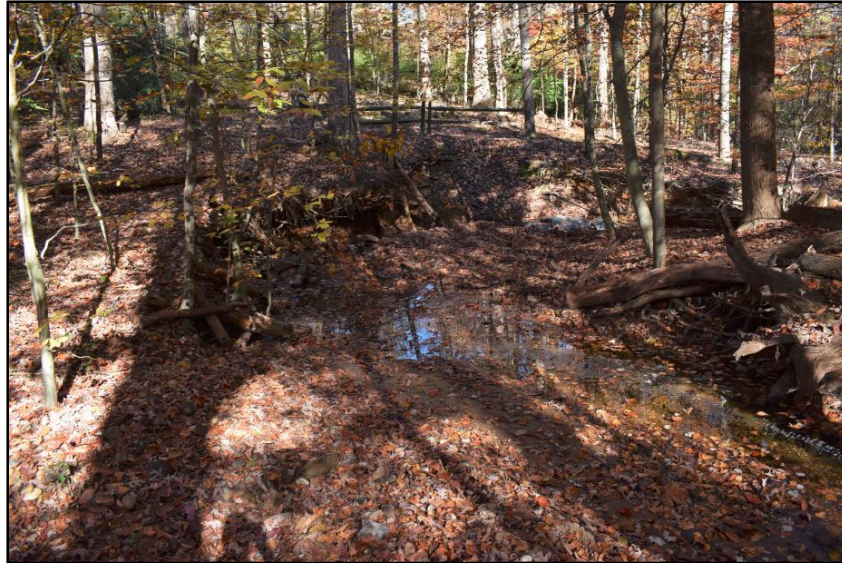
Figure 5. A highly sinuous meander on Tributary B near its confluence has remained relatively unchanged for decades as evidenced by the two large trees growing near the banks on both sides of the channel.

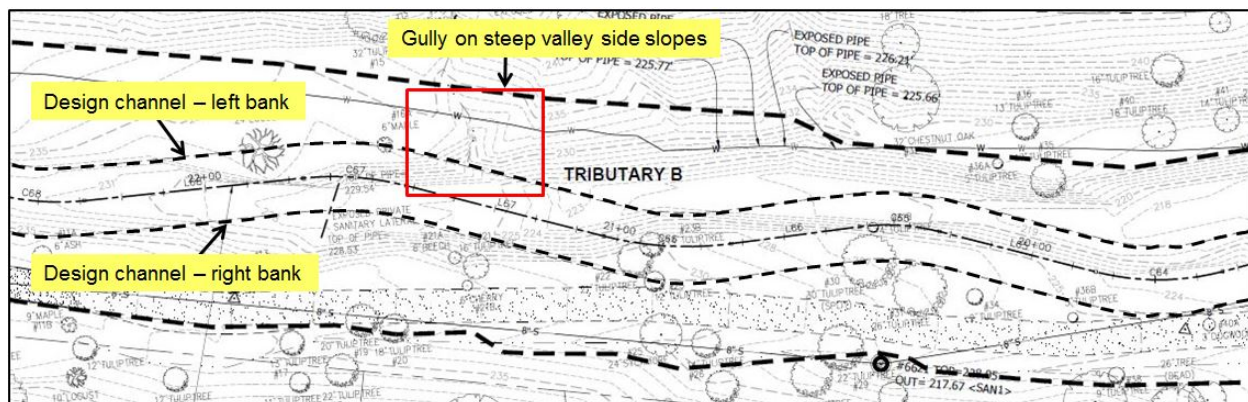
Figure 6. A portion of Drawing C-1 (VHB, 2019) showing proposed uniform meanders. Right and left bank are based on a downstream view with flow from left to right. The area highlighted by the red box is discussed in text.

The red box in Figure 6 highlights one of many locations where the design channel approaches the steep valley side slopes due to the lateral space needed to create the proposed meandering planform. At the highlighted location, a steep gully on the side slope will drain directly into the proposed channel and, as a result, could rapidly deposit large amounts of sediment. Such rapid inputs of sediment are unlikely along alluvial rivers that flow across a low floodplain, so the design (that essentially assumes Tributary B is alluvial) does not plan for such “outside” inputs of sediment and the proposed channel will be destabilized as a result.

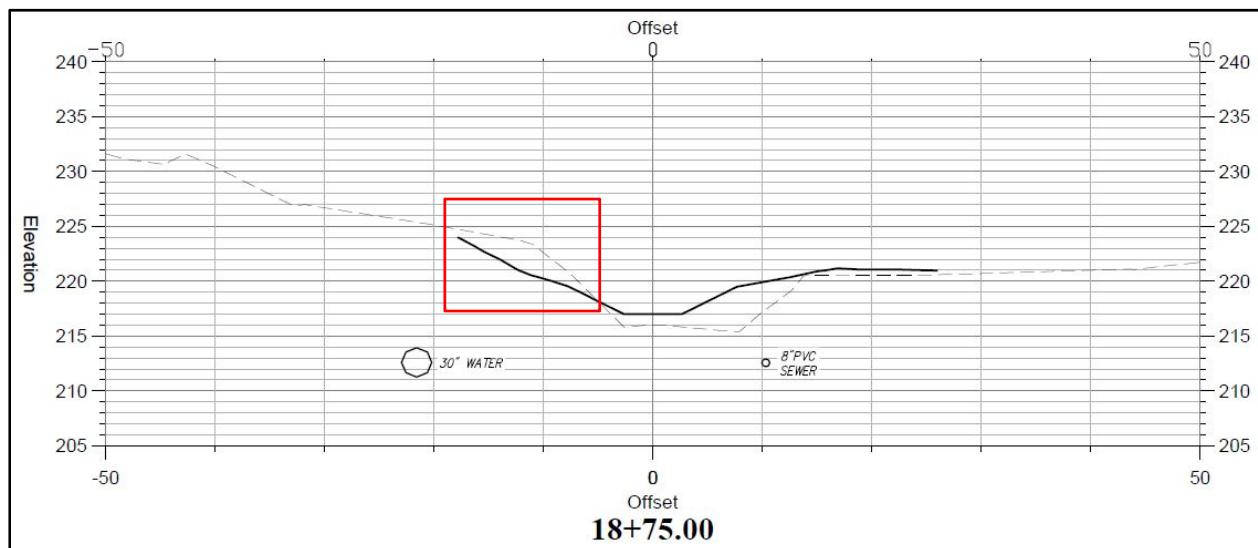
Figure 7. Cross section showing the proposed design channel (solid black line) will be excavated into the base of the high valley side slope (highlighted in red box). Note that the valley slope rises at least another 15 feet in elevation beyond the limits of the cross section. (From VHB, 2019, Drawing C-12)

Figure 7 is a cross section showing one location where the design channel will actually be excavated into the base of the steep valley side slope. This could destabilize the slope and trigger a landslide – a threat that will increase over time as flow in the design channel continues to impinge on and eat away at the slope. No evidence is provided in the design package (VHB, 2019) that documents a geotechnical analysis has been completed to determine the risk of such a landslide. The potential consequences of a landslide (or rapid inputs of sediment from the gully highlighted in Figure 6) would be to completely infill the design channel, allowing the flow to escape the design channel, reform a new channel elsewhere on the valley bottom, and cause the abandonment of the entire design channel downstream. This begs the question “Why does the design propose to form meanders in the upper confined section of Tributary B where no meanders ever existed before?” and also demonstrates that the primary project objective to stabilize the stream will not be achieved.

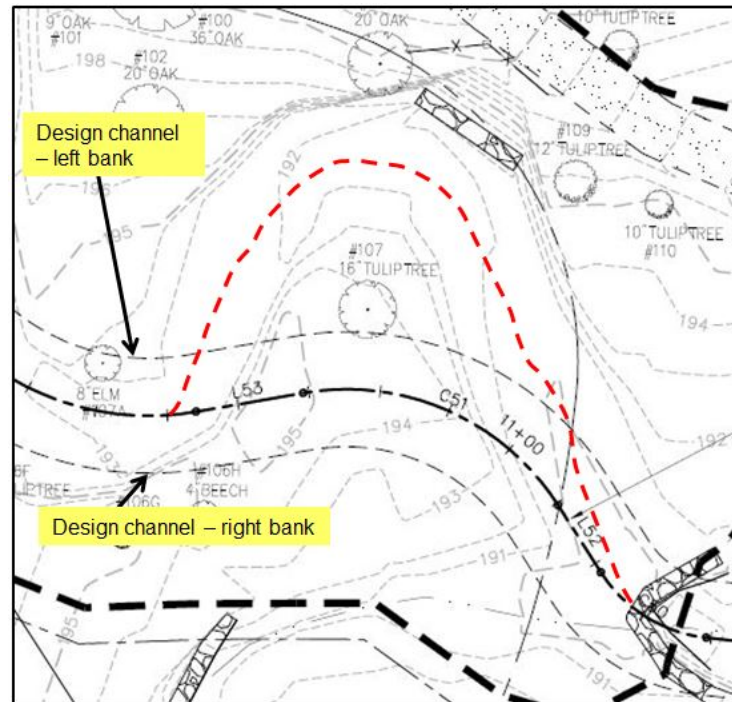
Figure 8. The lower sinuosity design channel proposes to cutoff the existing high sinuosity meander (centerline shown with dashed red line). (From VHB, 2019, Drawing C-2)

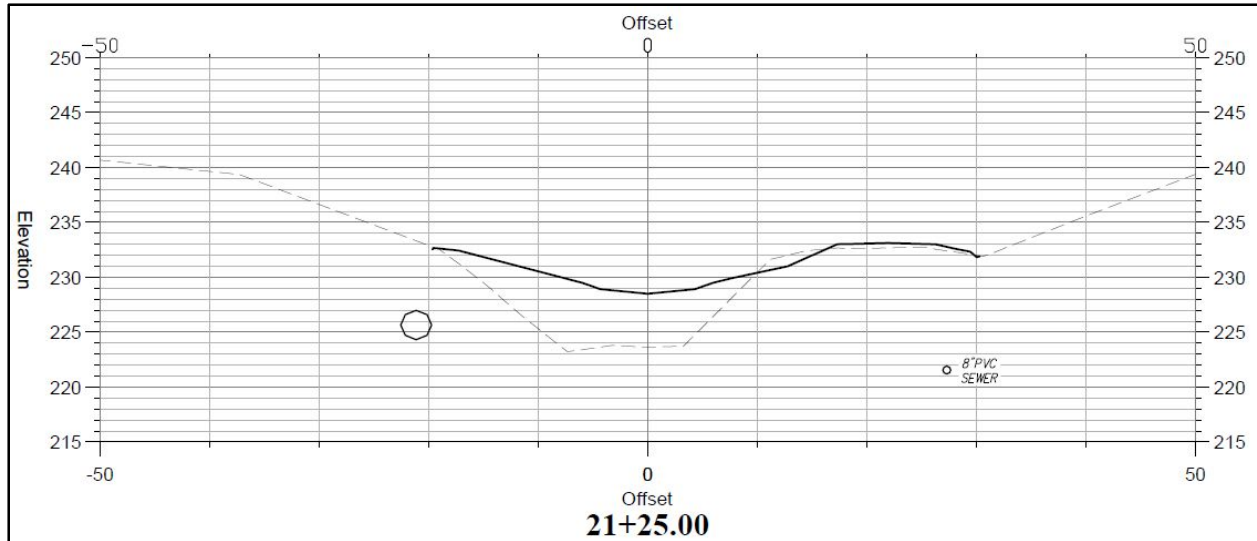
Figure 9. A typical cross section in the upper part of the restoration reach illustrating the difference in elevation between the existing channel (dashed line) and the proposed design channel (solid line). Fill will be needed where the solid line is above the dashed line. (From VHB, 2019, Drawing C-11)

VHB's (2019) restoration design proposes to fill, at least partially, the existing incised channel with what will presumably be a mixture of sand, silt, and clay (Figure 9). The amount of fill to be added is generally greater in the upper part of the proposed project with much less needed downstream where the existing stream is less incised. However, some fill is proposed for nearly the entire project's length. The cross section in Figure 9 is typical for the upper portion of the project with the depth of fill ranging from 5 to 7 feet depending on the position of the "thalweg" (i.e., deepest portion) and banks of the proposed channel. No details are provided in the design plans regarding the total volume, character, or origin of the fill to be used. The design justification for filling the existing channel with more than a thousand cubic yards of presumably imported fill is twofold: 1) to elevate the stream bed so that flows can more easily escape the channel and spread over the flat valley bottom in order to limit the stream power exerted in the design channel; and 2) to narrow the channel to approximate the expected width of an equilibrium channel in an undisturbed setting (with an adjustment factor added in recognition of urbanization as described in VHB, 2019, Drawing D-1).

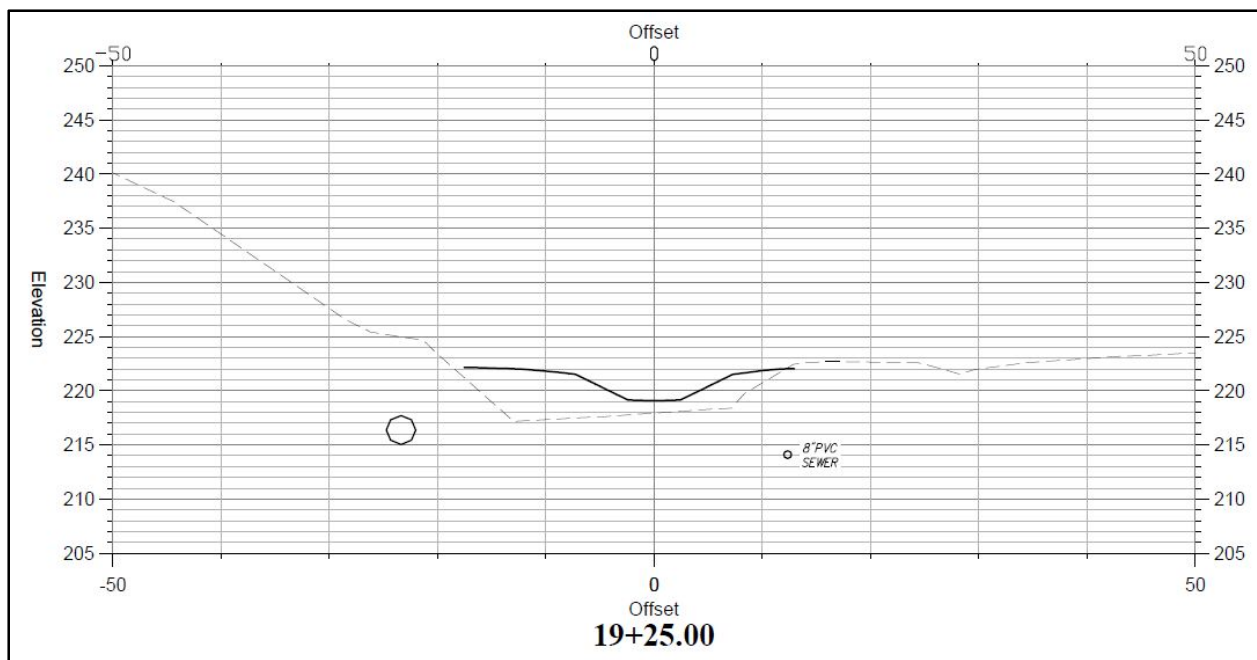
Figure 10. Cross section showing particularly well how fill placed in existing channel (dashed line) will create a narrower design channel (solid line) through most of the project's length. (From VHB, 2019, Drawing C-12)

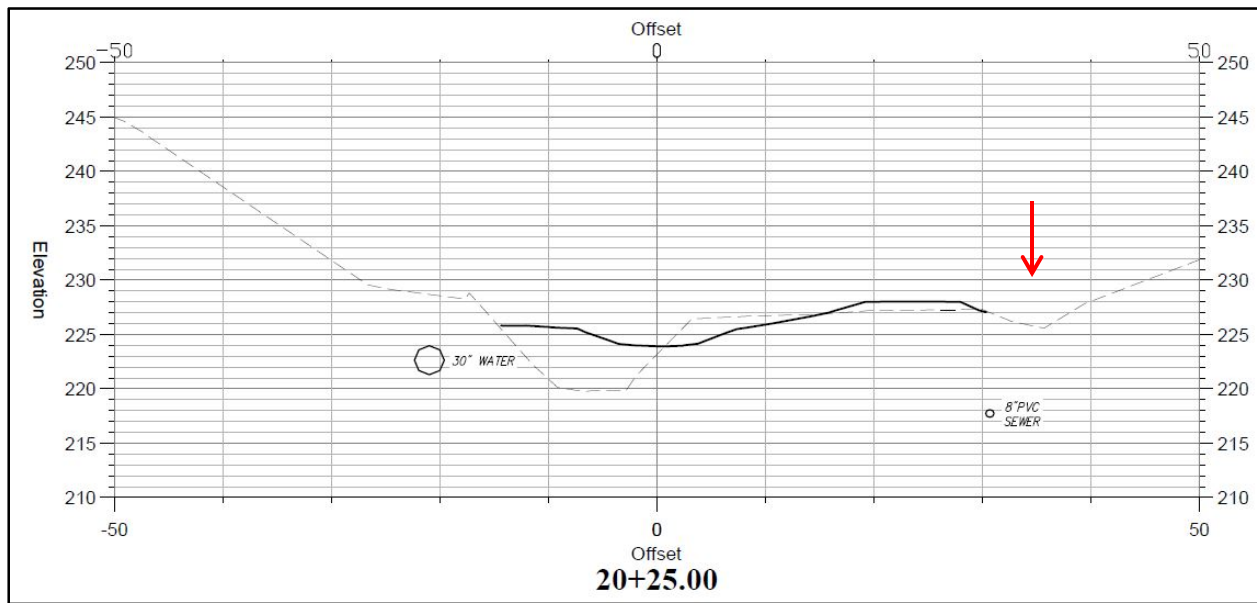
Figure 11. Cross section showing existing channel (dashed line) filled in to accommodate design channel (solid line), but leaving a low spot on the valley bottom (highlighted by red arrow) beyond the limit of disturbance. (From VHB, 2019, Drawing C-11)

The overbank flow emanating from the design channel will preferentially concentrate in these low spots on the valley bottom and could initiate channel incision to a depth lower than the design channel itself. In such an event, the design channel would be abandoned and the entire flow of the stream diverted to the newly incised channel. The potential damages from a new channel being carved on the valley bottom are significant as most of the existing low spots on the valley bottom are immediately adjacent to the sewer line. While the likelihood of such an event is low, dismissing a low risk event would be unwise given the potential high cost of repairs. By adding fill in the existing channel but leaving low spots on the valley bottom, the project could fail to meet its primary objective of stabilizing the stream and the project's explicit goal to protect adjacent infrastructure.

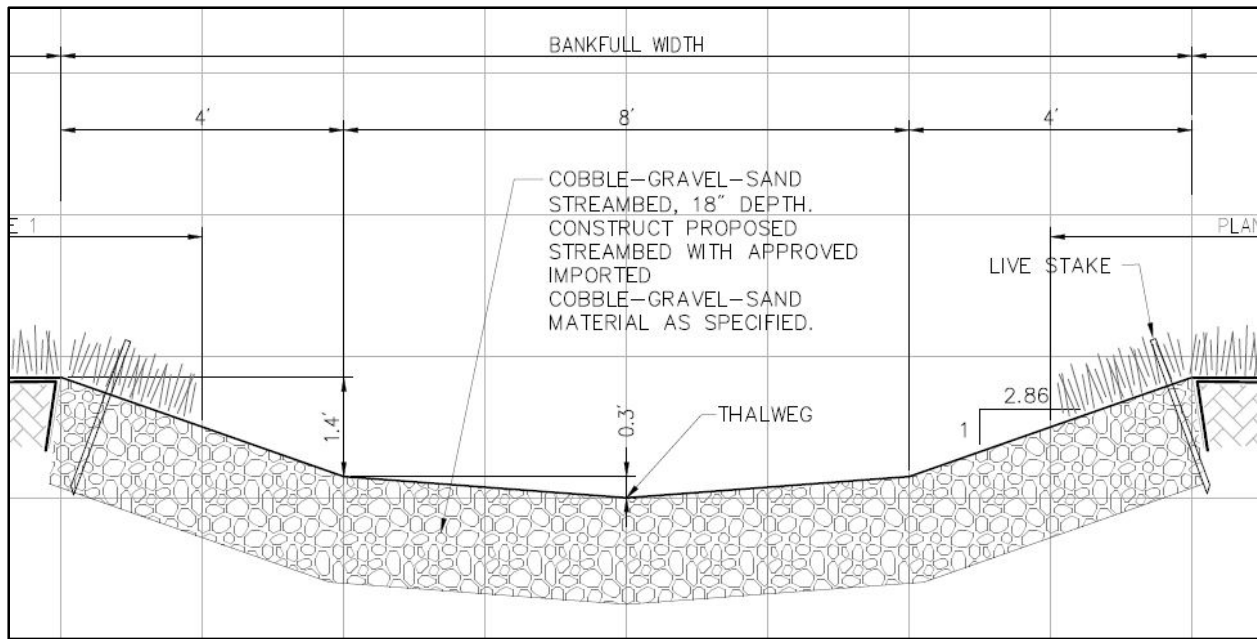
Figure 12. Portion of typical cross section showing 18-inch rock bed layer to be added to design channel along the length of the restoration project (From VHB, 2019, Drawing C-6)

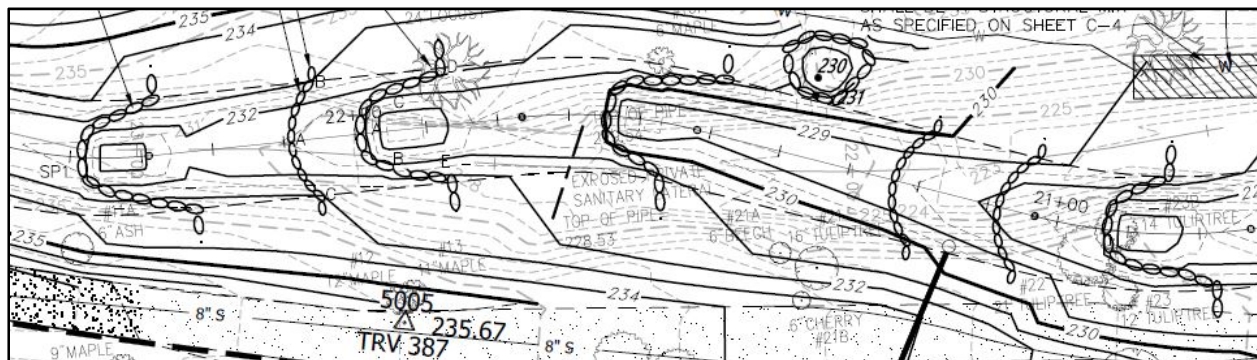
Figure 12. Portion of design plan showing several of the boulder step structures to be built across the proposed channel along its entire length. (From VHB, 2019, Drawing C-7)

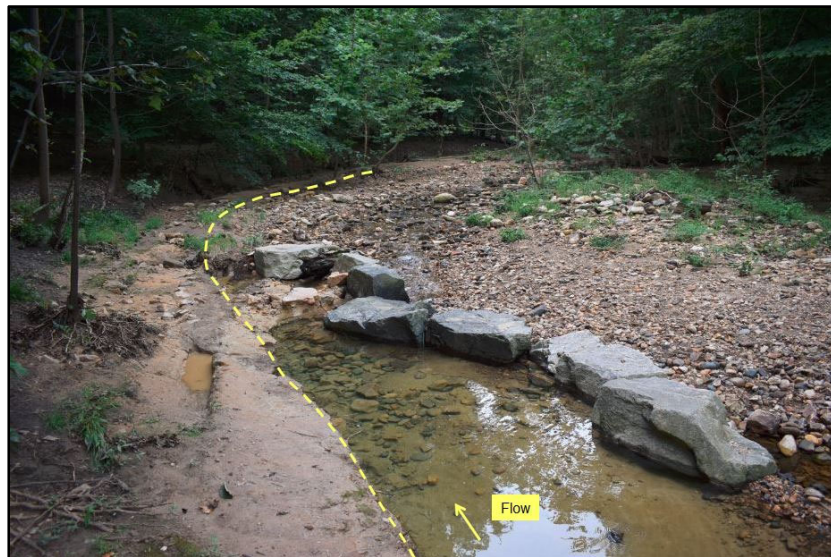
Figure 13. Outflanked boulder structure installed as part of Donaldson Run Tributary A restoration. Dashed yellow line approximates position of bank at completion of construction but is now well within the channel limits such that the boulder structure is not functioning as intended – note gravel bar against the boulders where a pool should be.

The use of the large boulders to form the rock step structures also presents problems. Boulder steps are natural features found on confined and steep mountain streams. While the upper portion of the restoration reach on Donaldson Run Tributary B is confined and fairly steep, the soils are largely composed of fine-grained material with no boulders occurring naturally. When stream flows encounter a contact between large immobile boulders and fine erodible sediment, the stream will preferentially and aggressively scour the fine sediments on the bed or banks of the channel. Since the boulder steps will be set below the coarse bed layer (VHB, 2019, Drawing C-5), undermining of the structures seems less likely than the “outflanking” of the structures (i.e., lateral erosion around the steps) due to bank erosion. Similar outflanking of boulder structures occurred as a result of bank erosion along the design channel constructed as part of the nearby Donaldson Run Tributary A restoration completed in 2006 (Figure 13).

Again, this is not hyperbole but exactly what has happened along the immediately adjacent restoration project on Tributary A (Figure 13) and other projects in the mid-Atlantic region (Miller and Kochel, 2010). Why are so many large boulders being used in a Natural Channel Design project at a site where no boulders exist naturally? The ability to sustainably achieve the project goals on Tributary B will be greatly compromised, not enhanced, by the use of boulders to create step-like structures.

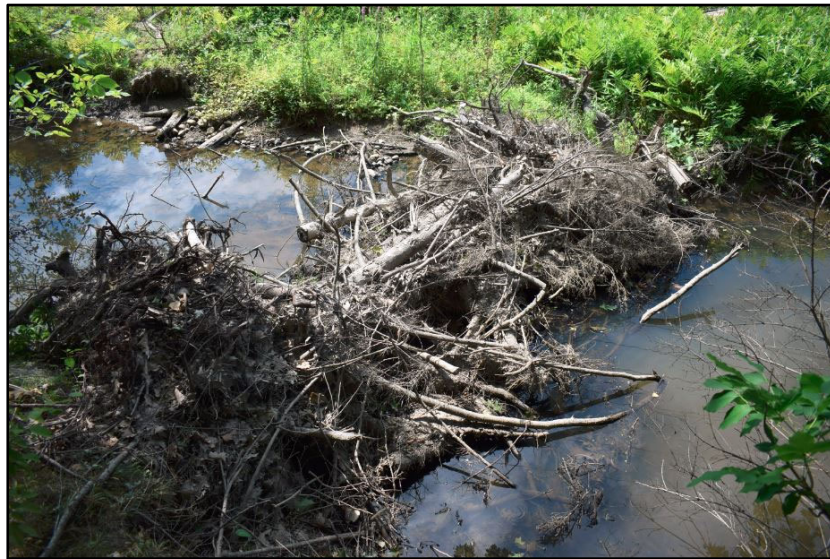
Figure 14. Low log jam structure built for an urban stream restoration project in South Portland, ME. Such log jams on Tributary B would extend only partially up the high banks and could be used to dissipate the high energy flows emerging from the culvert outlet at the upstream end of the project.

Wood added to the channel for the purpose of sediment storage along Tributary B could take the form of low log jams (Figure 14) or random placements of large logs to appear like natural tree fall. Sediment would be stored upstream of the log structures and when filled to the top of the logs could create step-like structures with plunge pools forming downstream as envisioned for the boulder steps in the current design plan (VHB, 2019). Furthermore, the sediment storage, over time, leads to channel narrowing in a sustainable manner (Figure 16b) as opposed to the Natural Channel Design proposal (VHB, 2016) that is unlikely to maintain the constructed narrow channel (see Section 4.2 above). Wood would be best placed where bedrock has been exposed, since a stream bed composed of gravel and cobble would be better for macroinvertebrate colonization than sheer rock. However, wood structures promoting sediment storage and energy dissipation would be beneficial throughout the length of the project.

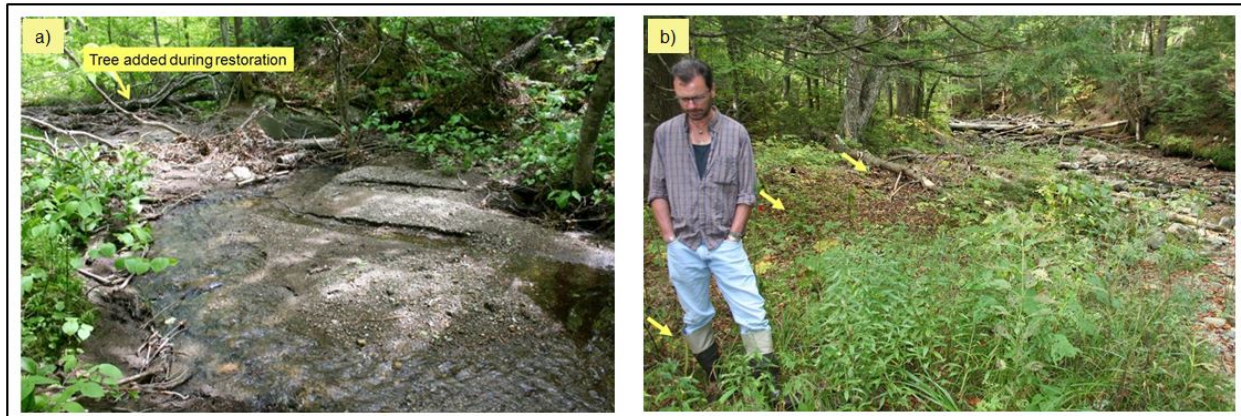
Figure 16. Wood addition projects on two small streams in the Green Mountain National Forest, VT. Photos taken a) one year after completion and b) 20 years after completion (arrows at edge of channel prior to wood addition). Note considerable sediment accumulation following one year and how after 20 years a revegetated floodplain developed as the channel narrowed as a result of the sediment storage.
